## CONDITION ASSESSMENT AND LEAK DETECTION

**Date:** 10/04/2021

**Project Number:** 42221059

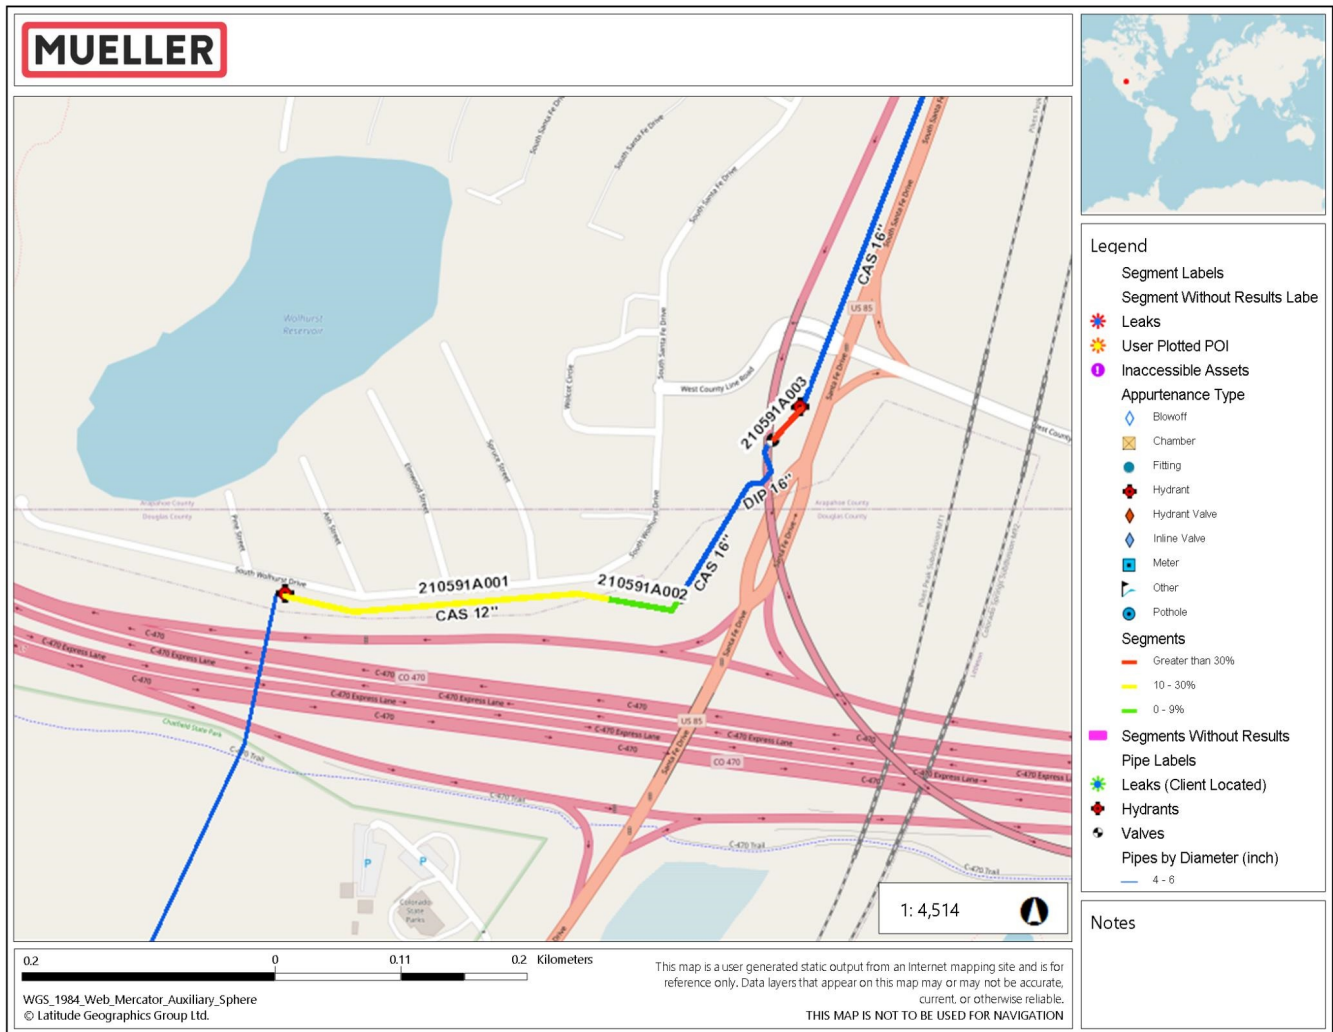
Figure A-1:

Table A-1: ePulse® Condition Assessment Results

Segment	Street	Blue Sensor	White Sensor	Length	Pipe Size	Pipe Material	Nominal Thickness	Effective Wall Thickness	% Change from Nominal Thickness
				(feet)	(in)		(in)	(in)	
210591A001		FHV10716035	Echo-4	814	12	CI	0.49	0.43	-12
210591A002		VV10724226	Echo-4	202	12	CI	0.49	0.49	0
210591A003		FHV10716036	11246457	102	16	CI	0.56	0.32	-43

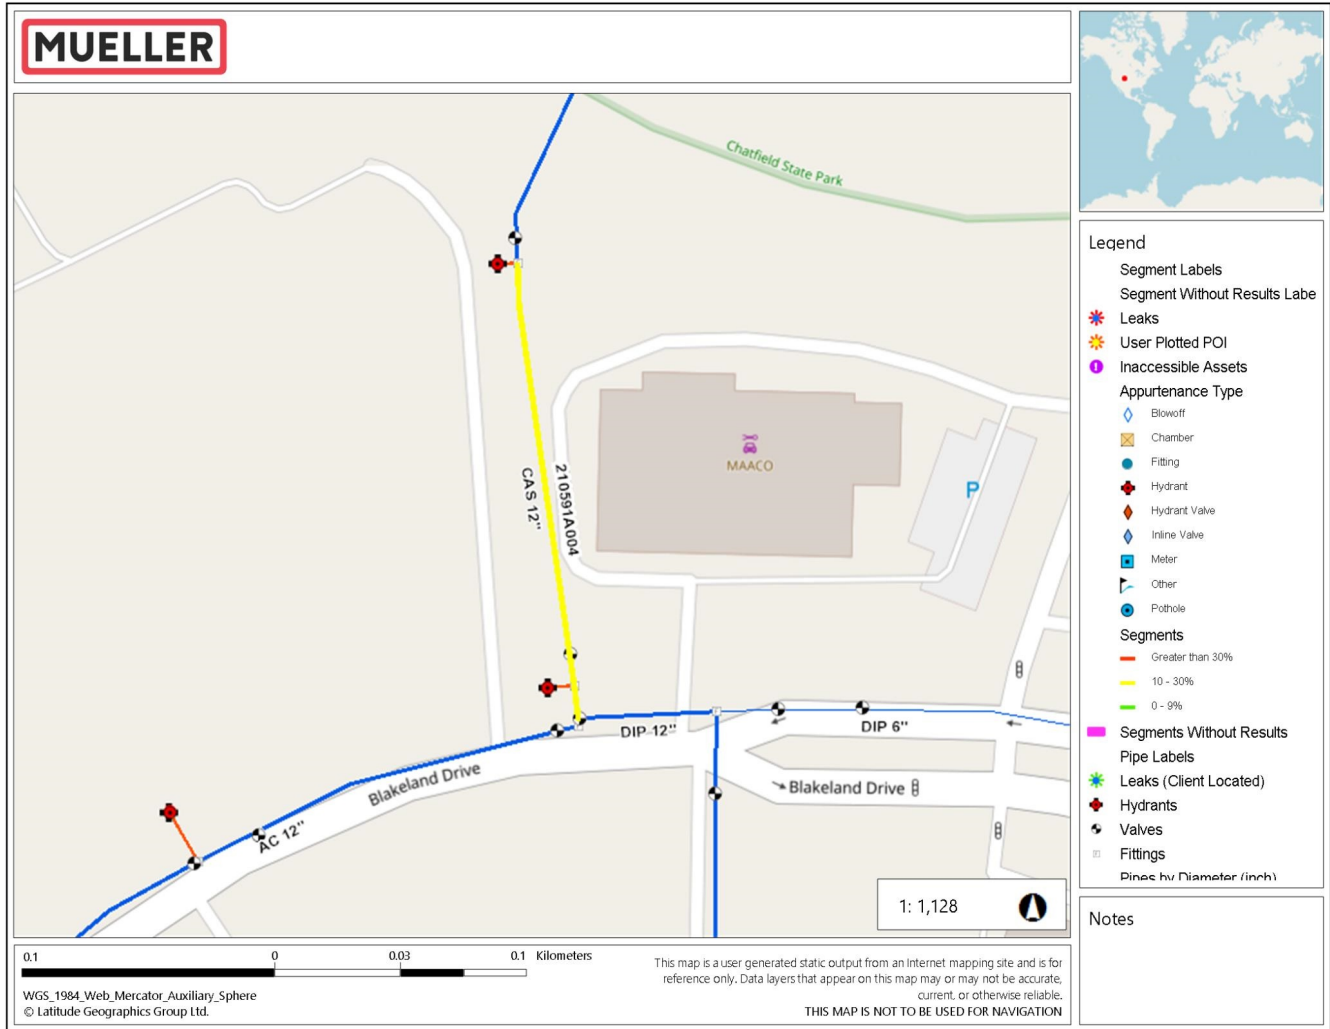
Figure A-2:

Table A-2: ePulse® Condition Assessment Results

Segment	Street	Blue Sensor	White Sensor	Length	Pipe Size	Pipe Material	Nominal Thickness	Effective Wall Thickness	% Change from Nominal Thickness
				(feet)	(in)		(in)	(in)	
210591A004		VV10724223	Echo-6	253	12	CI	0.49	0.37	-24

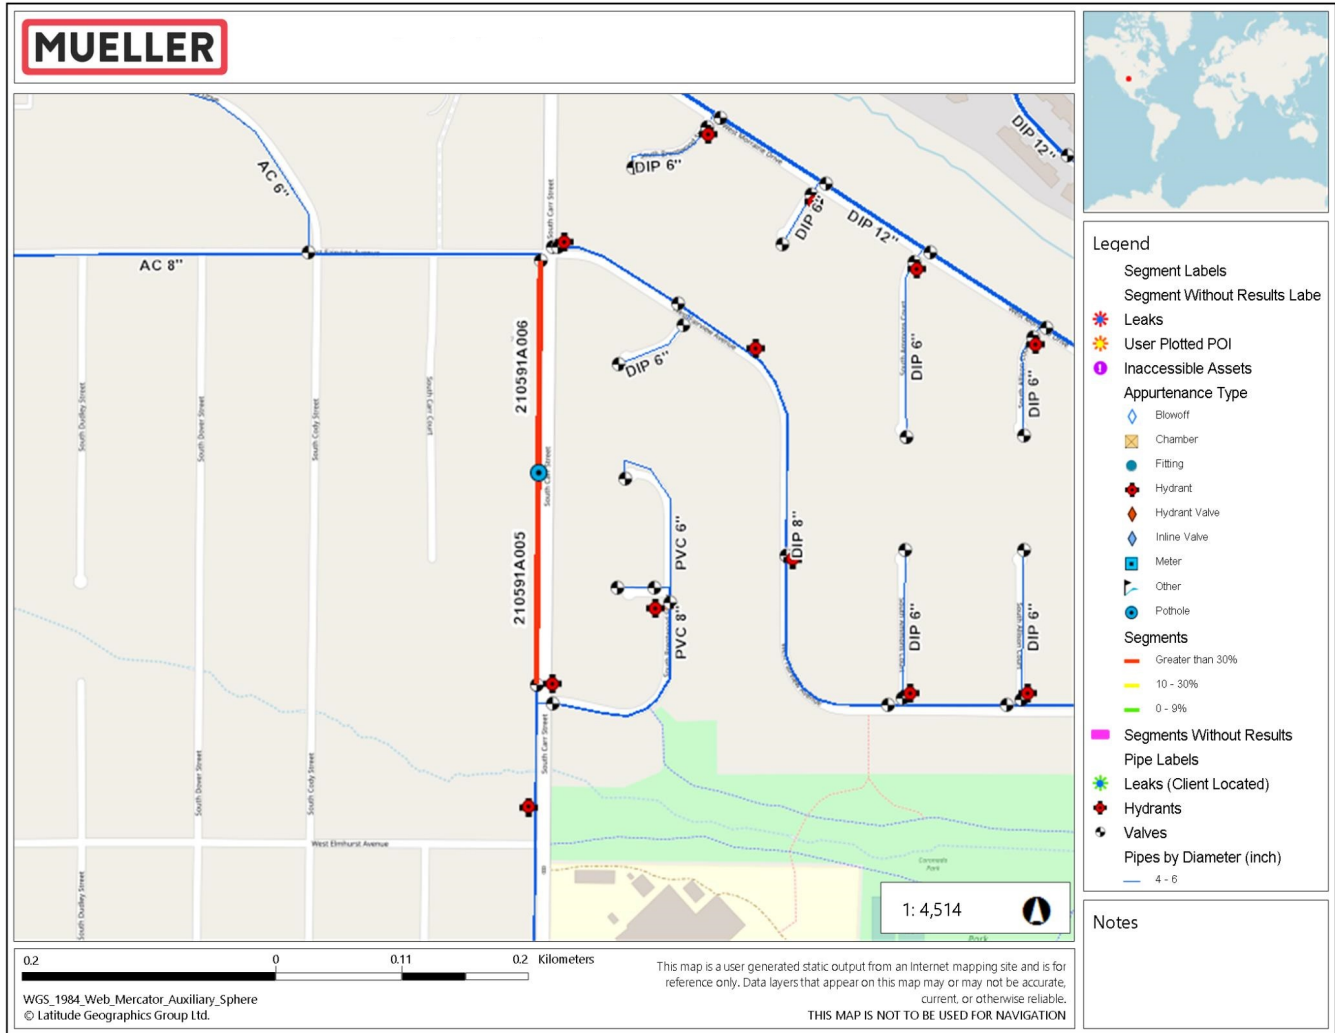
Figure A-3: Table A.1-3: ePulse® Condition Assessment Results

Segment	Street	Blue Sensor	White Sensor	Length	Pipe Size	Pipe Material	Nominal Thickness	Effective Wall Thickness	% Change from Nominal Thickness
				(feet)	(in)		(in)	(in)	
210591A005		PH3326-1	VV10723075	487	8	AC	0.76	0.40	-47
210591A006		PH3326-1	VV10723129	462	8	AC	0.76	0.46	-39

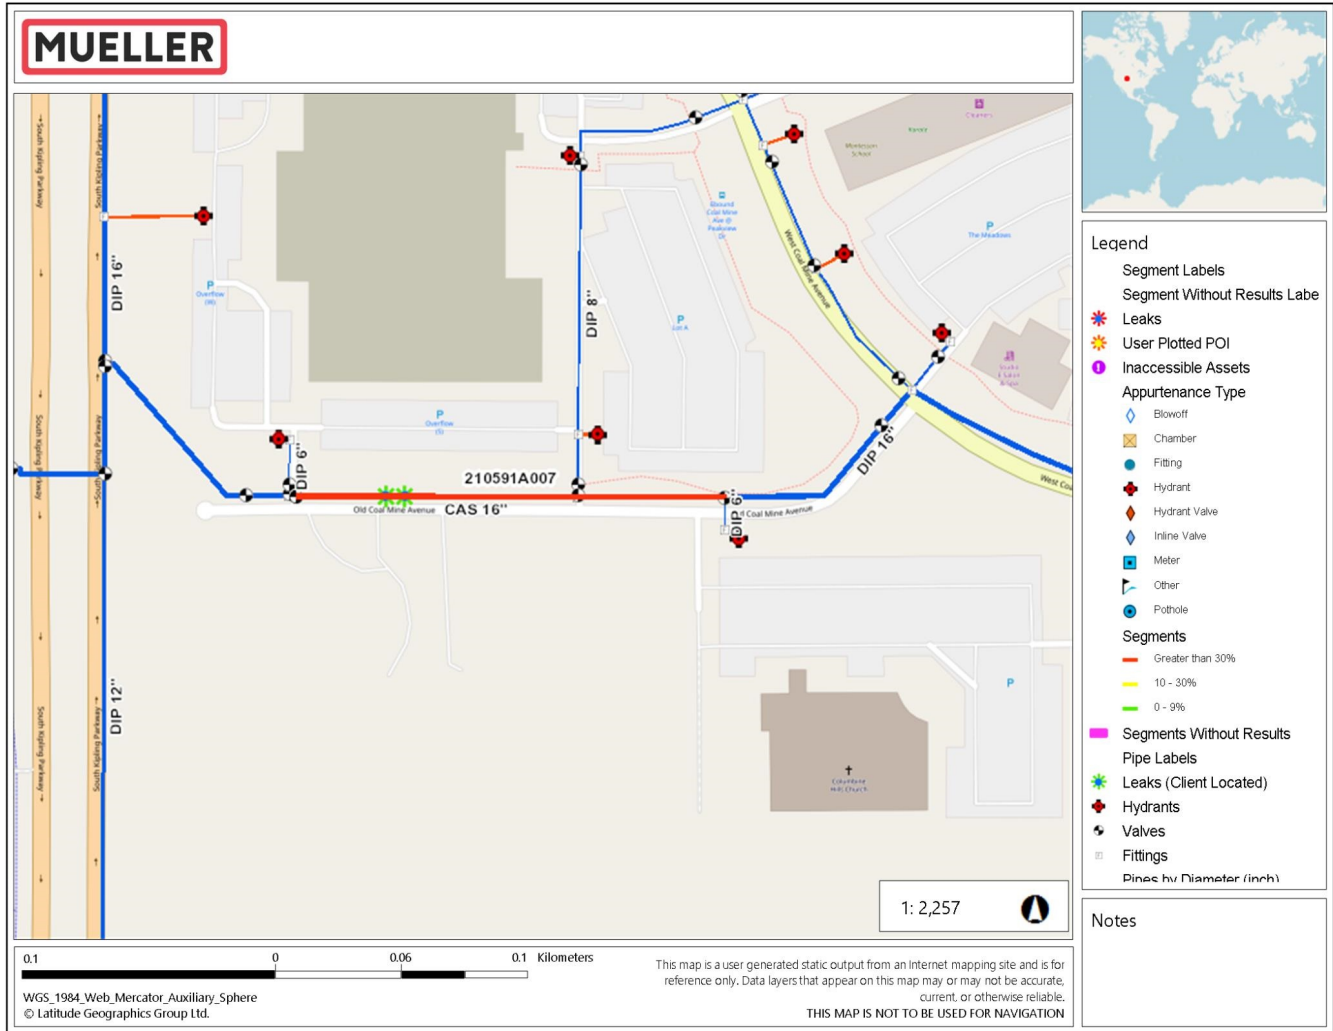
Figure A-4:

Table A-4: ePulse® Condition Assessment Results

Segment	Street	Blue Sensor	White Sensor	Length	Pipe Size	Pipe Material	Nominal Thickness	Effective Wall Thickness	% Change from Nominal Thickness
				(feet)	(in)		(in)	(in)	
210591A007		VV10725676	GIS-Vlv-5139	502	16	CI	0.56	0.39	-30

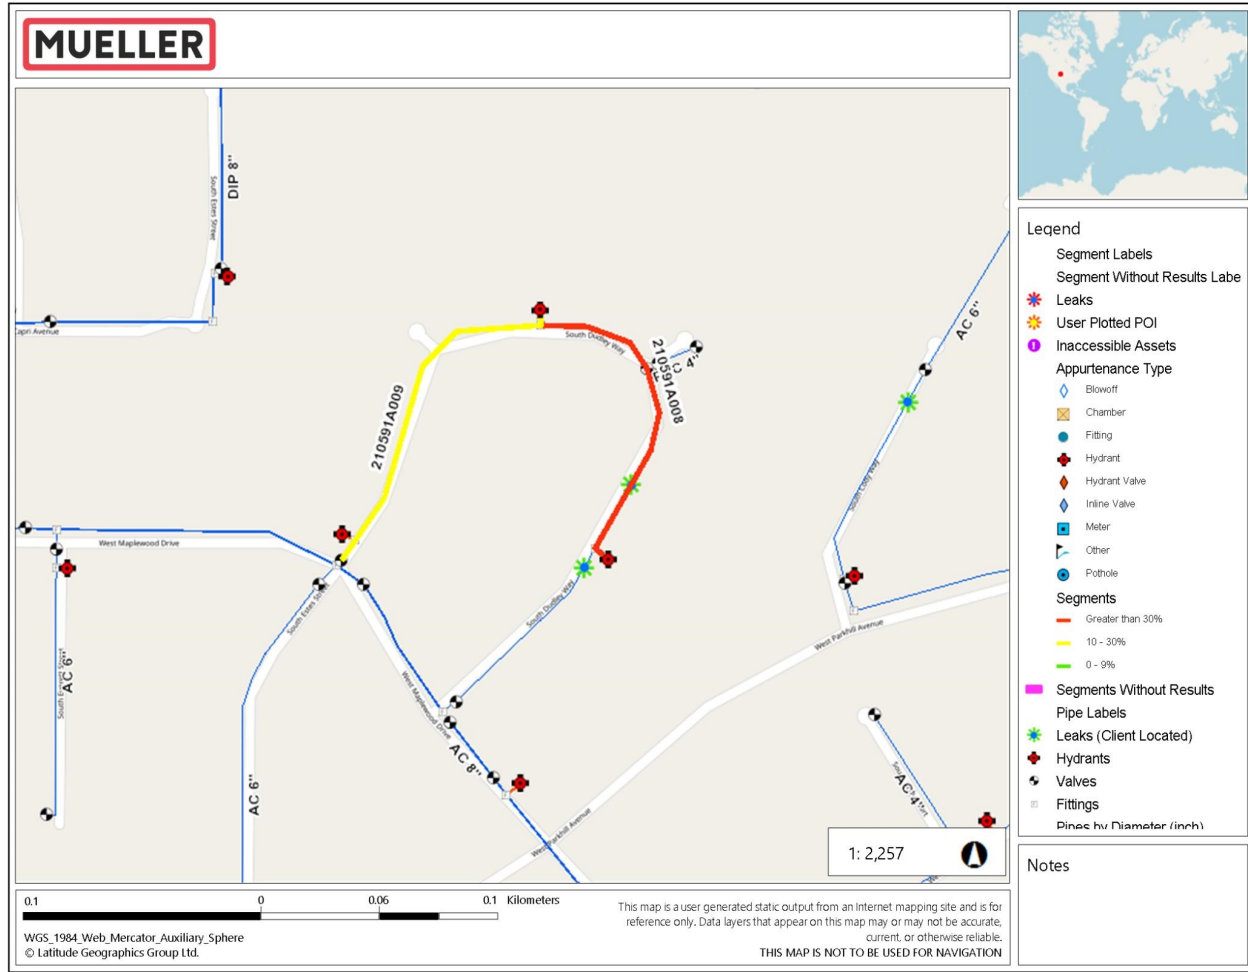
Figure A-4:

Table A-4: ePulse® Condition Assessment Results

Segment	Street	Blue Sensor	White Sensor	Length	Pipe Size	Pipe Material	Nominal Thickness	Effective Wall Thickness	% Change from Nominal Thickness
				(feet)	(in)		(in)	(in)	
210591A008		Echo-8	Echo-7	396	6	AC	0.66	0.45	-31
210591A009		WV10721759	Echo-7	409	6	AC	0.66	0.56	-15

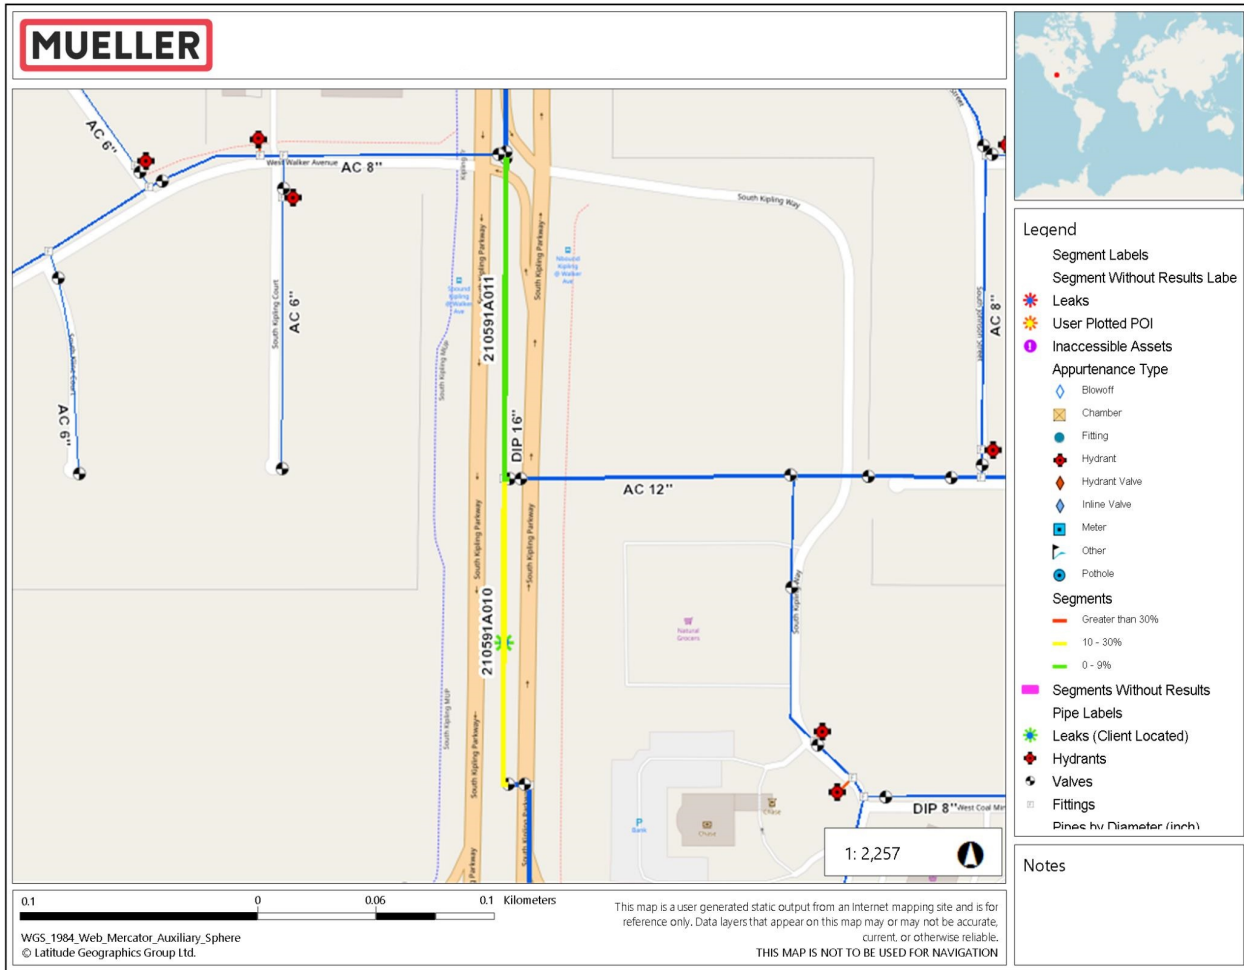
Figure A-5:

Table A-5: ePulse® Condition Assessment Results
