How to Economically and Accurately Assess the Condition of Small-Diameter Water Mains

Dan Ellison and Dave Spencer

August 13, 2020

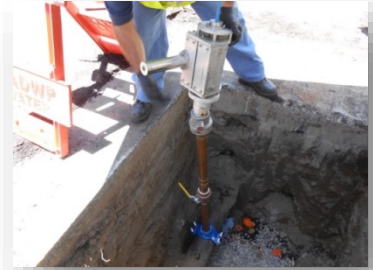
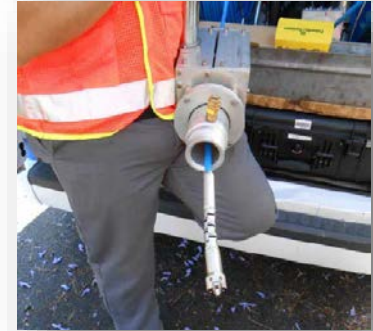
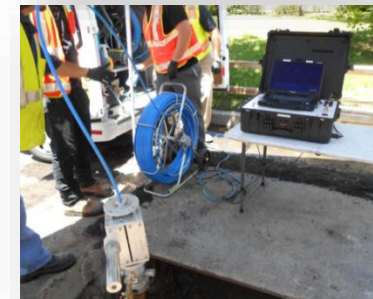
Push-in probe (Investigator)

- » Entry through 2-inch taps
- » **Video / audio (Wachs Water Service / Genivar)**
- » Advantage: little disruption of operation
- » Limitations:
 - Can only be pushed a hundred feet, more or less
 - Time consuming; degree of inspection is limited
 - Provided no condition information

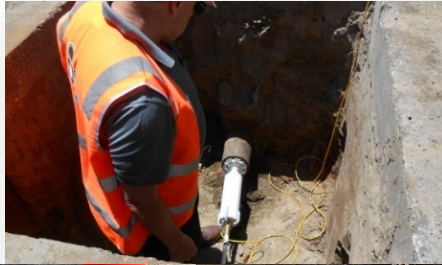
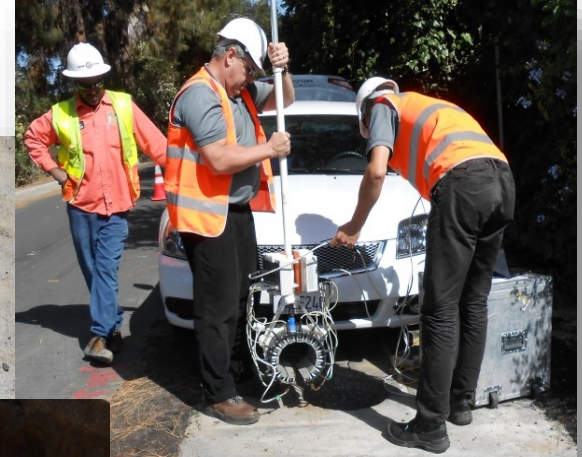
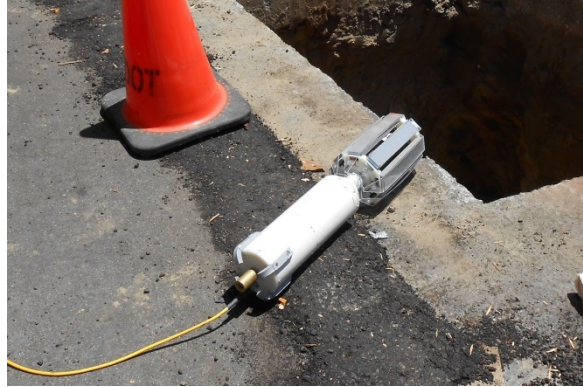
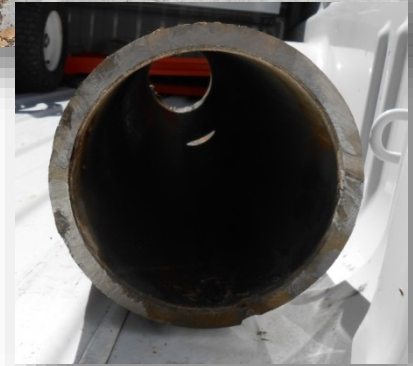
Broadband electromagnetic (Rock Solid)

- » External scanning using vacuum-excavated keyhole
- » Internal scanning of drained pipe
- » Limitations
 - Limited coverage
 - Time consuming
 - Dry, straight pipe needed for in-pipe inspection

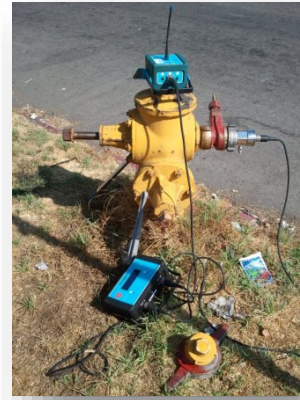
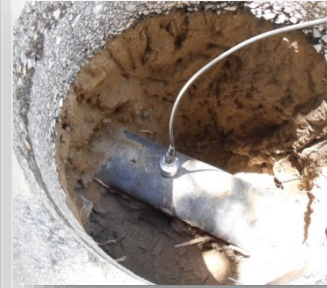
Acoustics velocity testing (Echologics)

- » **Non-Invasive.** Pipe access using existing appurtenances or vacuum-excavated keyholes.
- » Provides **average thickness** between transducers
- » Limitations:
 - **Does not detect isolated pitting**
 - » Information can be lost in data noise

$$v = v_o \times \sqrt{\frac{1}{\left[1 + \left(\frac{D_i}{t_r}\right) \times \left(\frac{K_l}{E}\right)\right]}}$$

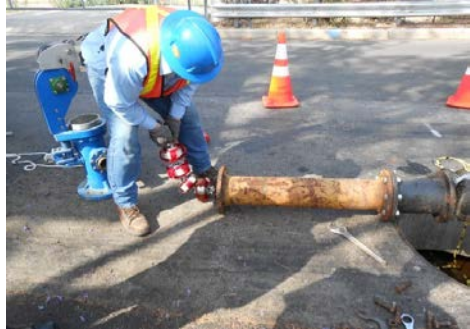
Inserting the tool into the launching port. Normally this tool is launched from a fire hydrant's vertical drop leg.

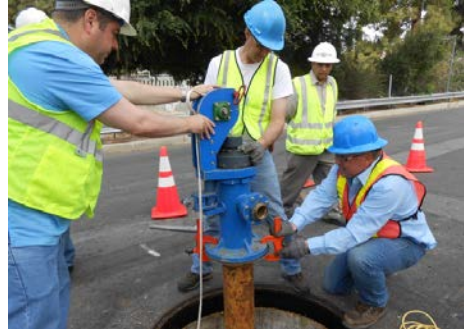
This custom hydrant guides the rope past a seal. By using clamps to hold the hydrant in place, flange patterns don't have to match.

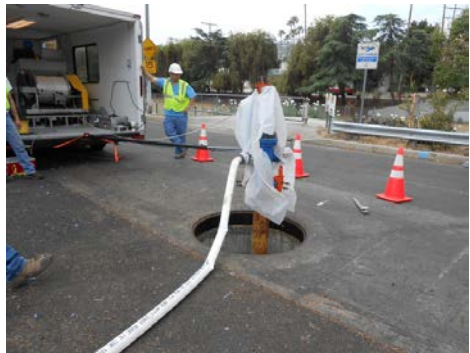
Ready to launch. The fire hose provided water to push the tool to the far end of the main. A plastic sheet contains water that leaks from the assembly. The hydrant is braced to the trailer to counteract the winching force.

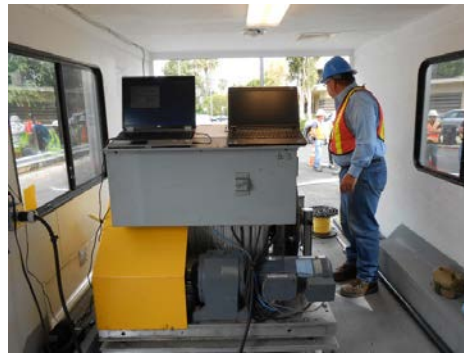
The location of the NDE tool is tracked by measuring the amount and speed of tether rope deployment. Underneath the table is the motor used to winch back the tool. All tools and equipment were powered from a small electrical generator.

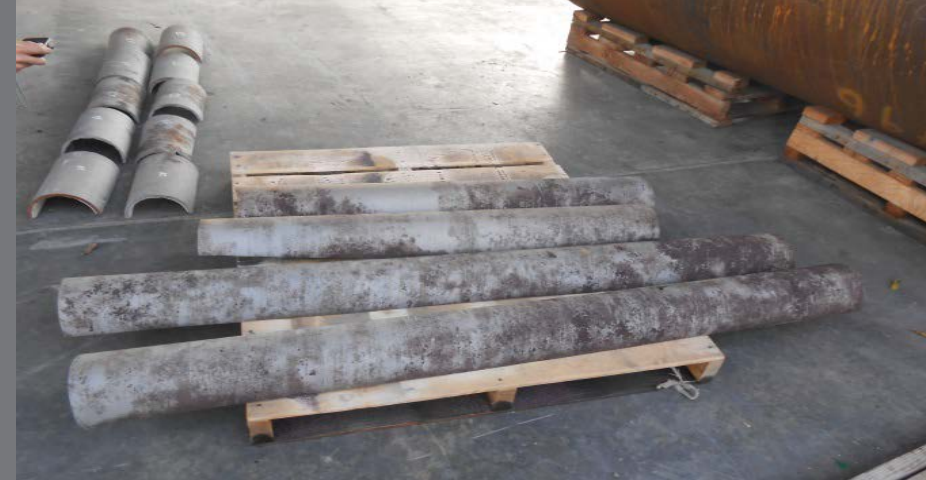
Seven pipe segments were split longitudinally into 14 pieces, then sandblasted.

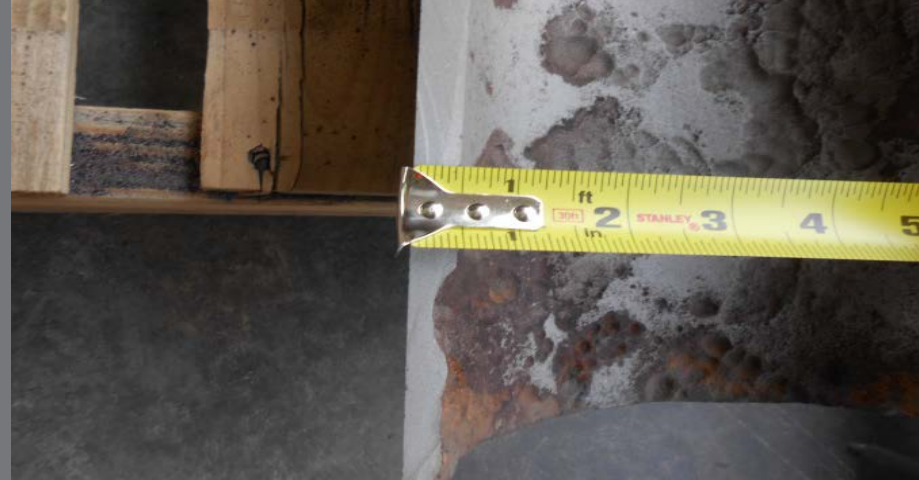
Uncorroded pipe measurements were generally 7/16-inch thickness (0.43 inch).

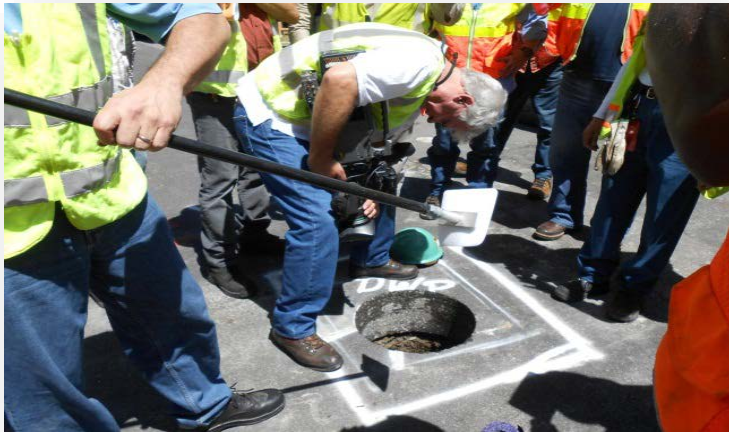
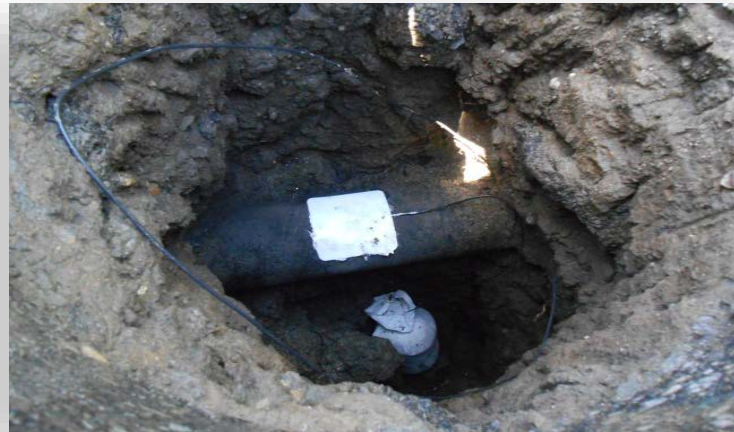
Phase 1: Findings and Conclusions

- No perfect method; interpretation is art and science
- **In-pipe remote field technology provided depth and breath**
- 80 percent of Valleyheart main was “Good” to “Excellent”
- A cost-effective strategy for Valleyheart main might have been:
 - Line the unlined 1933 pipe
 - Install a few anodes near repair areas

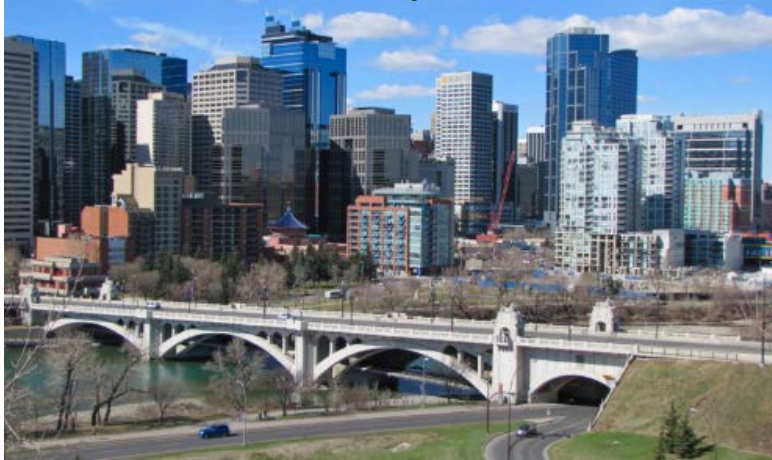
Calgary - Centre Street Bridge Historic Landmark & Transport Corridor

Planned Shut Downs Once Every 20 Years (2000)

Decision: Replace 1946 CI Pipe?

Decided not to replace
Southern section

Pipe hasn't broken yet
(17 years)

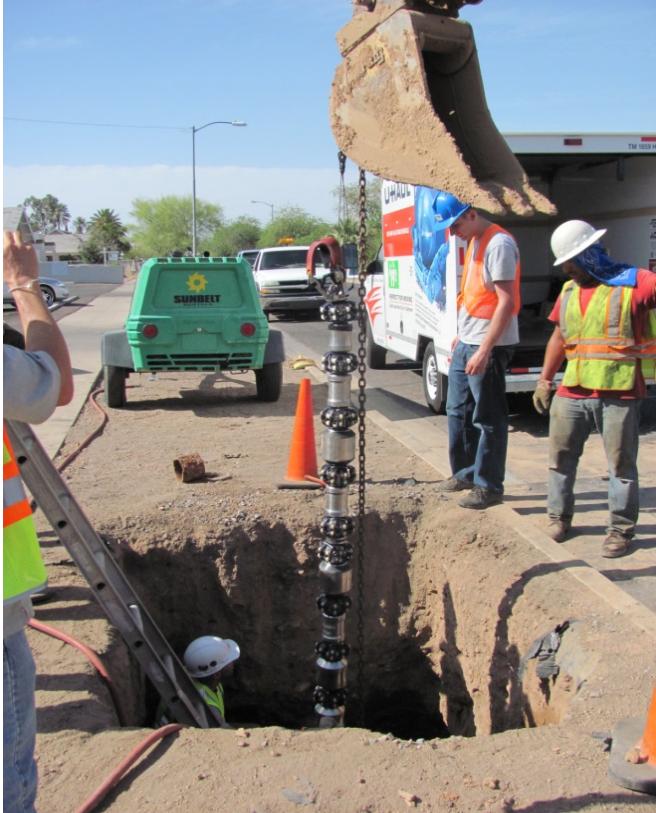
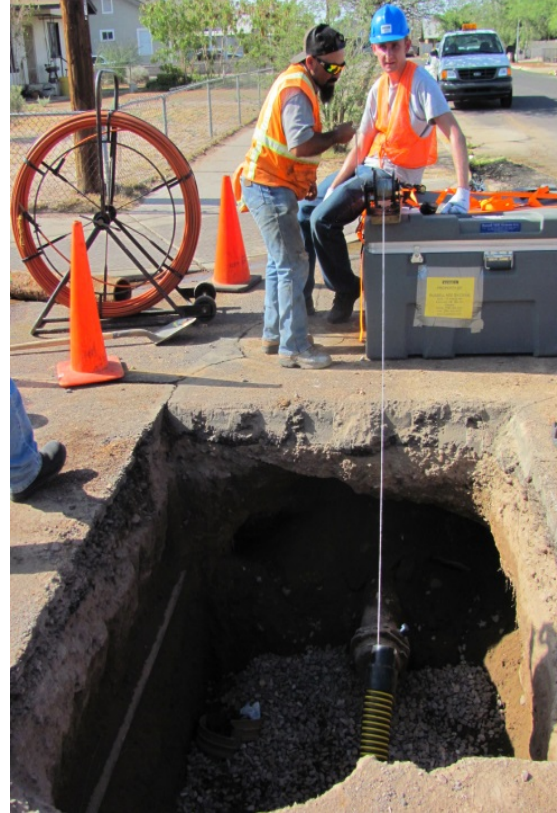
Field demonstration in Phoenix

Phoenix Results Showed the Potential Benefits of the Method

- » Several deep pits
- » Widely scattered pits
- » Minimal overall metal loss

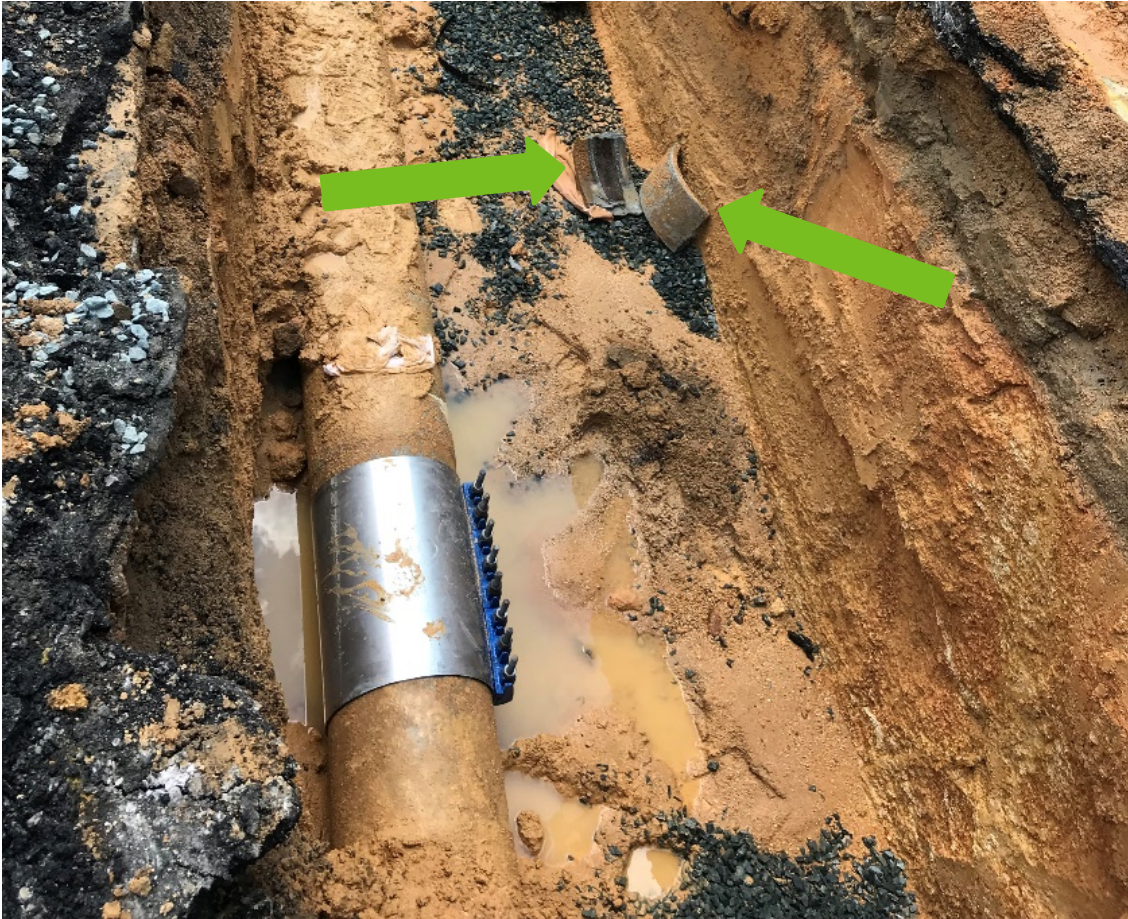
AC Samples Can be Small (1" or more, full wall thickness)

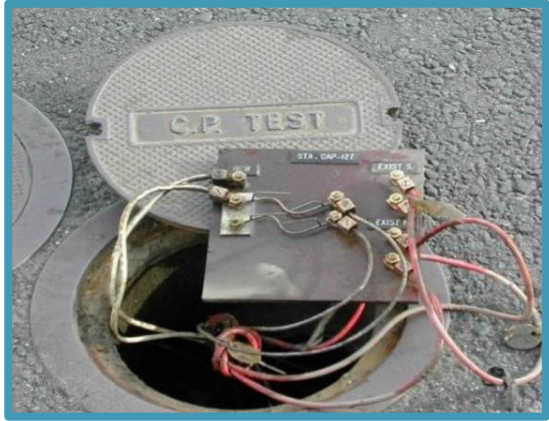
Larger, Electrically Continuous Pipes

(~90% less expensive)

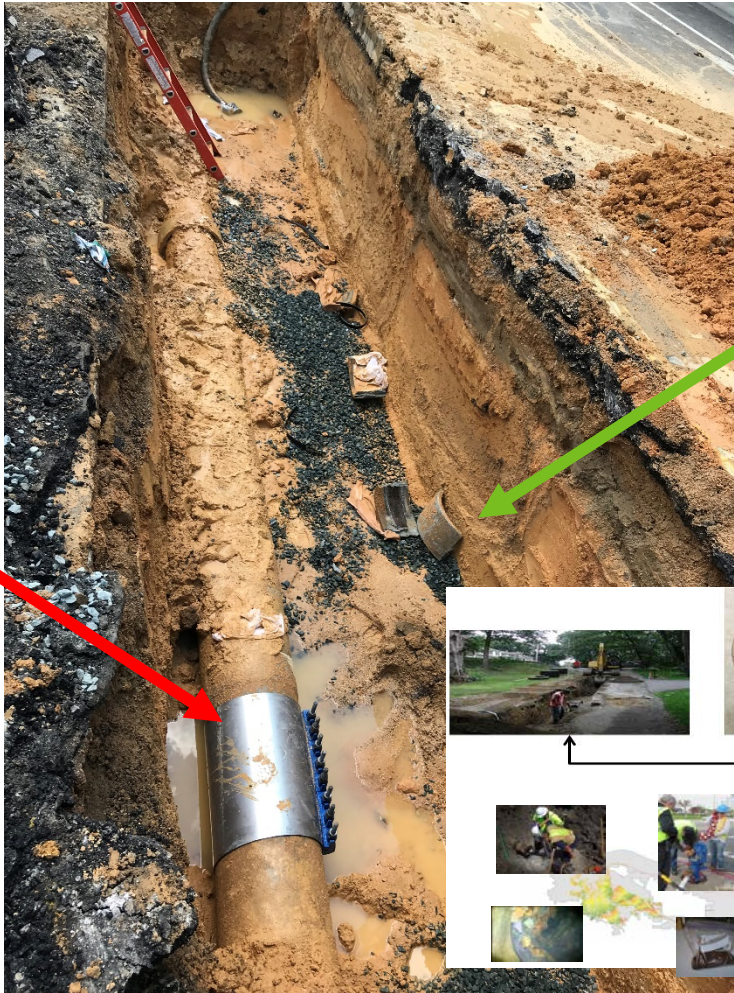
SOPs, Tools, & Training

Opportunistic Condition Assessment Activities for a Main Break or Valve/Pipe Replacement

Metallic/PVC Pipe Sampling (Rare)	Soil Sampling (All Pipe)	Final Checks & Close Out
<ul style="list-style-type: none"> ➤ Only sample if the break is severe and you must cut pipe ➤ Remove the broken pipe area plus 2 ft. on either side ➤ Label the sample with the work order number, date, and location and place in the sample bucket 	<ul style="list-style-type: none"> ➤ Locate native soil, as close to pipe depth as possible, that hasn't been contaminated by potable water ➤ Collect ~1 pound (quart freezer bag partially filled). ➤ Label the soil sample with the work order number, date, and location using Sharpie marker ➤ Place soil bag in the soil sampling bucket 	<ul style="list-style-type: none"> Check that all samples have been collected and labeled
AC Sampling (common)		
<p>1</p> <p>Is an AC cut needed?</p> <p>Yes</p> <p>Mark the top of the pipe</p> <p>No</p> <p>Can you obtain a piece with the full pipe wall?</p> <p>Yes</p> <p>1. Place sample in two thick resealable bags</p> <p>2. Label bag and with work order number</p> <p>No</p> <p>No sample collected</p>	<p>2</p> <p>Wrap pipe and label with work order number and seal</p> <p>1. Place sample in bucket and seal</p> <p>2. Mark W/O# on bucket</p> <p>3. Place bucket on Pallet</p>	<p>3</p> <p>Back at Yard</p> <p>1. Place sample(s) into small bucket marked "final AC Samples"</p> <p>2. Reseal bucket</p> <p>End AC Sampling</p>

<p>Finalize Work Order</p> <ul style="list-style-type: none"> - Verify pipe material and size - Check that pictures have been uploaded <p>Place samples on pallet in warehouse</p> <p>Refill bucket supplies if necessary</p> <ul style="list-style-type: none"> - Plastic wrap - Sharpie & labels - Resealable bags - Tape - Charged voltmeter (5v battery) - Deionized or distilled water - Wire brush

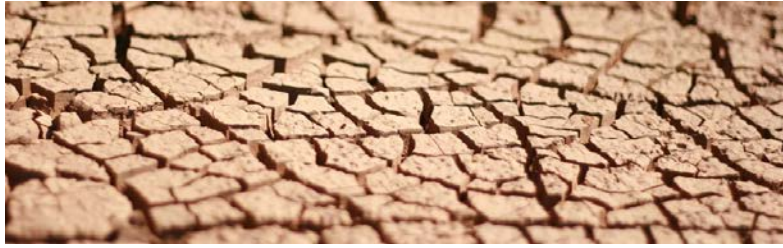
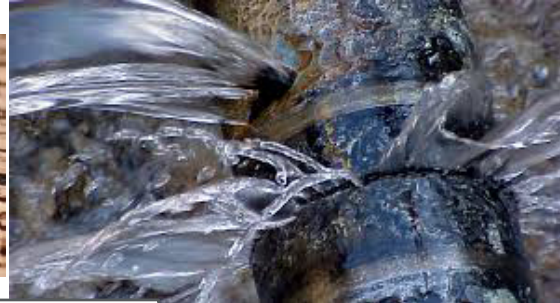
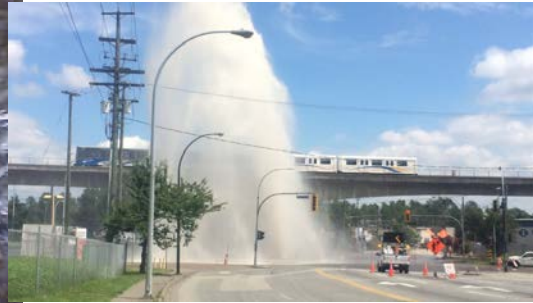
For brittle AC pipe, Condition & STRESS → Breaks

Ground Movement

Pressure

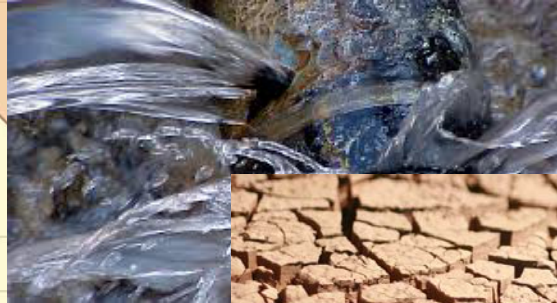
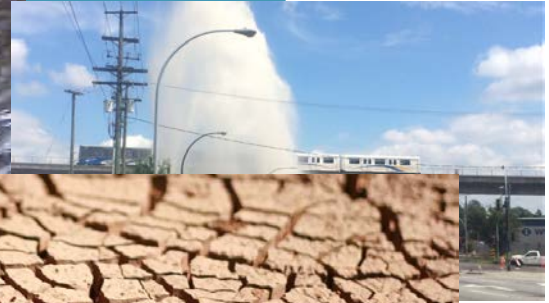
LoF Rating

Percent Remaining Wall	Stress	
	Low	High
Less than 50%	Very High	Very High
50% to 57%	High	Very High
57% to 62%	High	High
62% to 67%	Moderate	High
67% to 72%	Moderate	Moderate
72% to 77%	Low	Moderate
77% to 82%	Very Low	Low
More than 82%	Very Low	Very Low

Quantify Relationship: Stress, Condition, Breaks
